NL INDUSTRIES/TARACORP SUPERFUND SITE GROUP
Leed Environmental, Inc.
Van Reed Office Plaza
2209 Quarry Drive, Suite C-35
Reading, PA 19609
Telephone: (610) 670-7310
Facsimile: (610) 670-7311

Re: NL Industries/Taracorp Superfund Site; Granite City, Illinois
First 2020 Semi-Annual Operation and Maintenance Inspection (June 2020)

**NL Industries/Taracorp Superfund Site
Inspection Log - Operation and Maintenance**

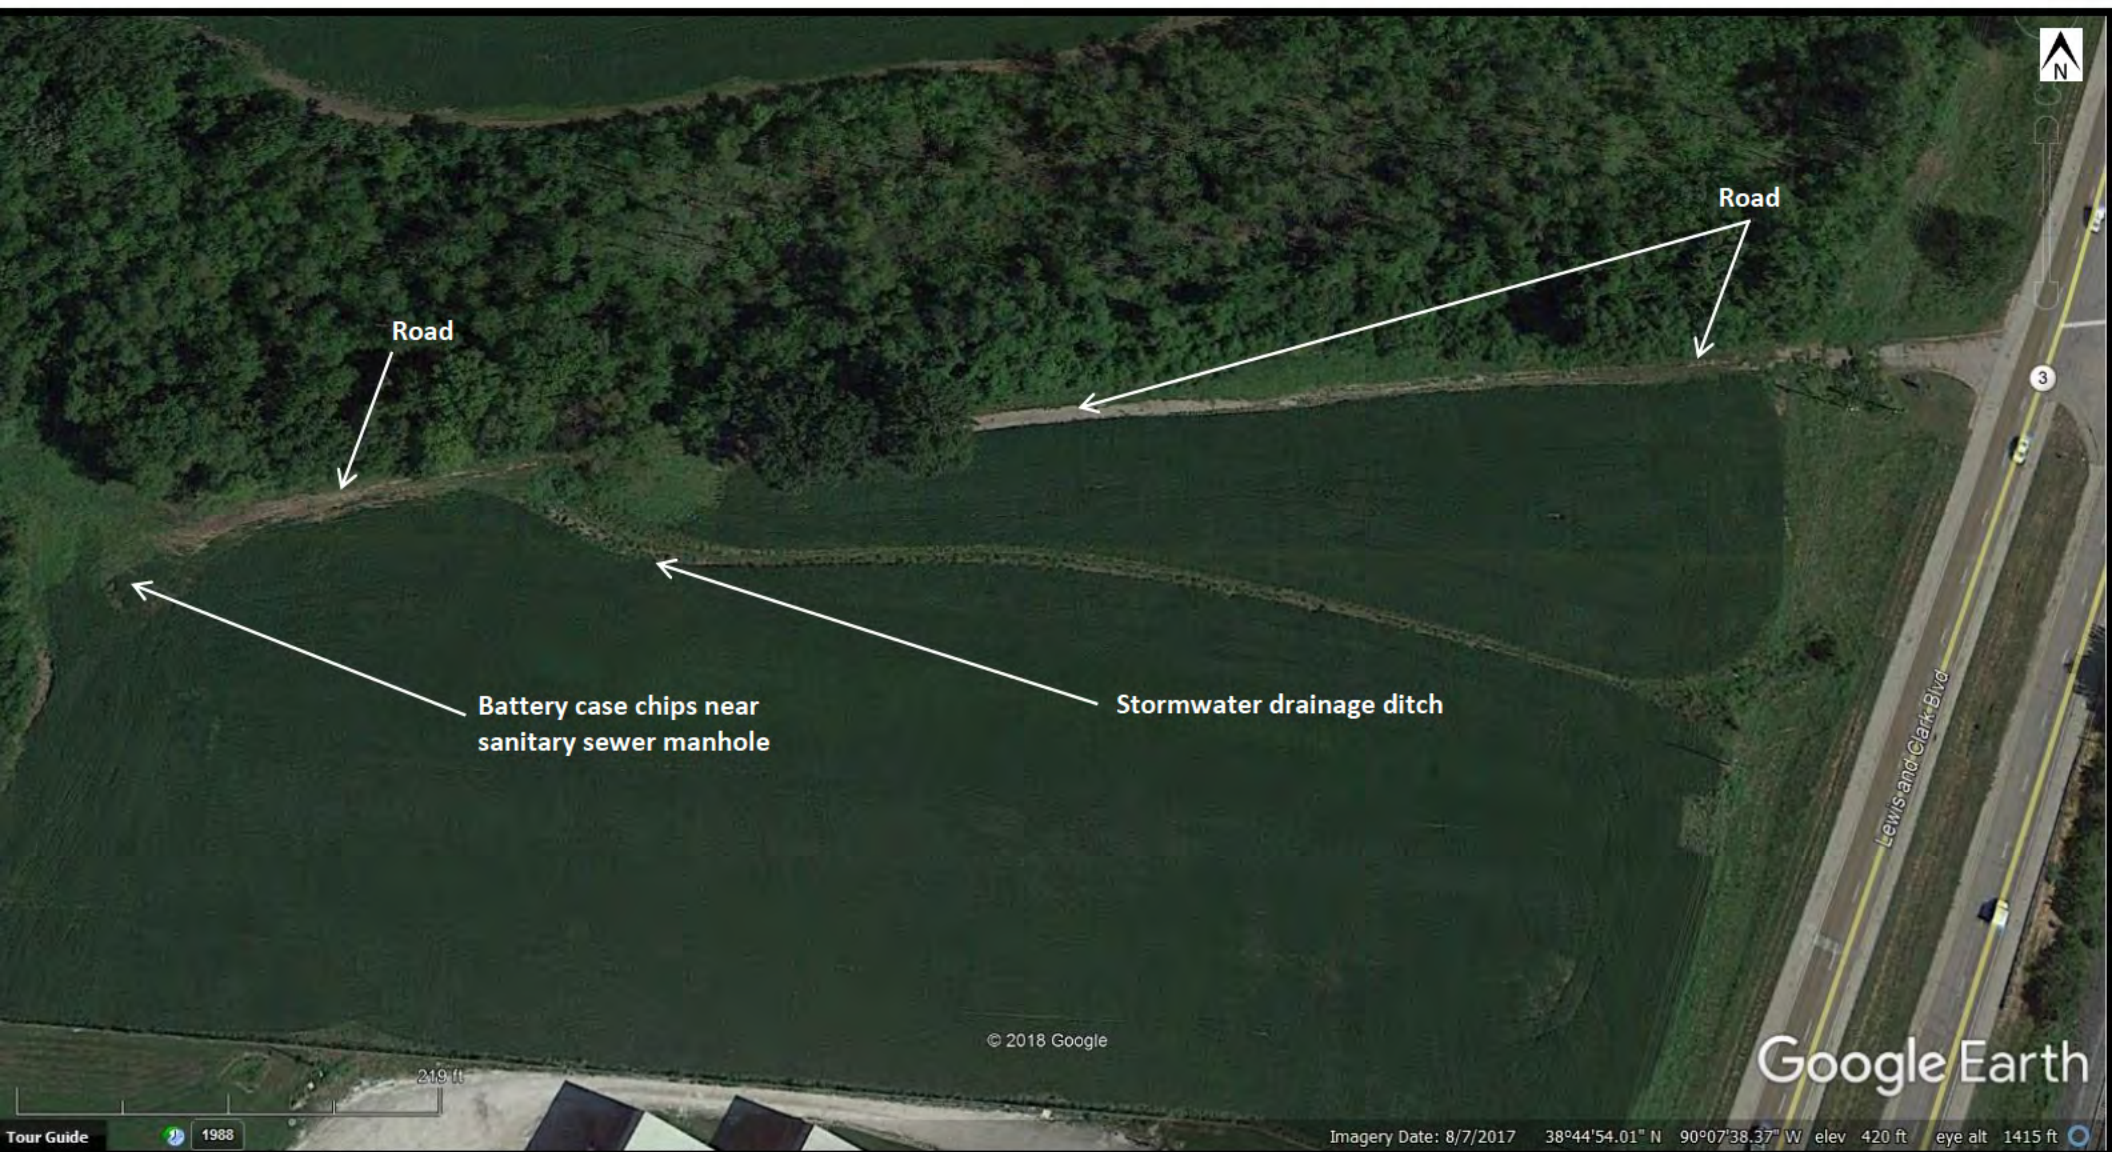
Figure 5
Schaeffer Road

- As shown on the photographs in Attachment 6, no evidence of disturbance of the soil cover or asphalt roadway was observed at Schaeffer Road (a remote fill property remediated by EPA). Several scattered battery case chips were observed on the ground surface near a sanitary sewer manhole located near the western end of Schaeffer Road at the approximate location on Figure 5. This area is currently being farmed.

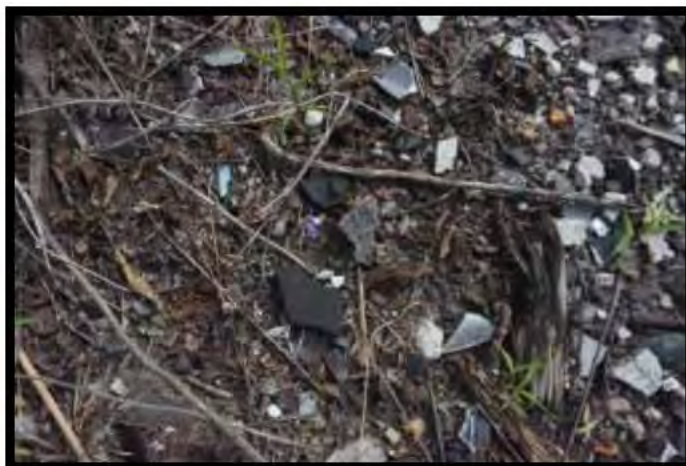
- At Slough Road (shown on Figure 1 and the photographs in Attachment 1), no disturbance of the gravel cover to the previously paved area was observed. Also, I met with Mr. Earl Boyd, Terminal Manager for Beelman River Terminals, Inc. (Beelman), who confirmed that there has been no disturbance to the paved surface of Slough Road (which is no longer visible) since the time the paved roadway was covered with soil/gravel fill as part of the expansion of Beelman's operations. Mr. Boyd also indicated that Ameren has placed stakes into the ground to mark the location of its new electrical transmission tower; this area was not observed, but the area is located outside (to the west/southwest) of the former Slough Road area. Some scattered battery case chips were observed on the concrete foundation of the former Robin's Nest lounge.

Photograph 11: Slough Road, battery case chips on foundation of former Robin's Nest Lounge.

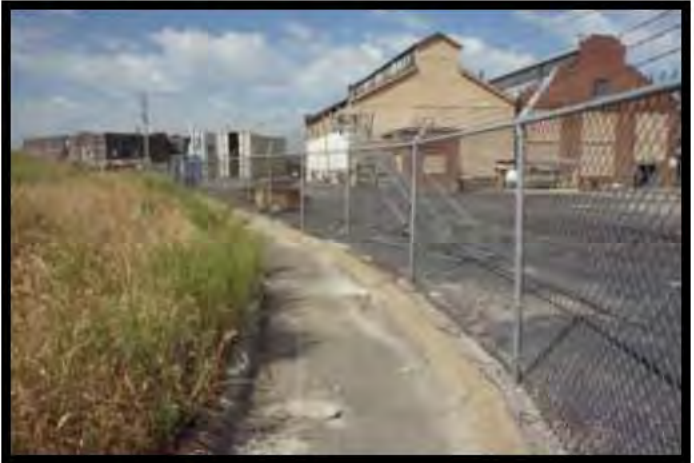
Comments			No problems identified. Leachate level checked during five-year review site work.	
Concrete Drainage Channel Around Taracorp Pile				
Evidence of cracks or other deterioration	Yes	Yes	Some cracks observed in concrete drainage channel (probably from mowing). No evidence of adverse impacts to surface water drainage.	
Evidence of obstructions	Yes	No		
Evidence of erosion	Yes	No		
Evidence of improper drainage	Yes	No		
Comments				
Retention Basin for Stormwater Runoff				
Adequate vegetation	Yes	No		
Evidence of erosion or deterioration	Yes	No		
Appropriate drainage to storm sewer	Yes	No		
Comments			No problems with retention basin evident.	
Concrete Sidewalk (1555 State Street Property)				
Evidence of cracks or other deterioration	Yes	No		
Comments			Concrete sidewalk is in good condition; no problems identified.

Photograph 16: Concrete drainage swale, crack in concrete along northwestern side of Taracorp pile.

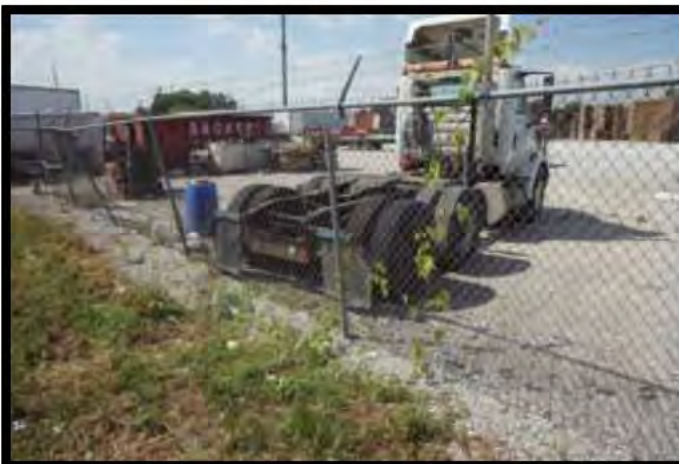
Photograph 40: Fence along State Street Warehouse storage area, bent fence and broken fence pole.

- The Group has notified the owner/operator of All Pallet Services, one of the companies that operates on the neighboring property, and has requested that All Pallet Services repair a bent section of fence, a separated fence post, and some torn barbed wire (Attachment 5, photographs 40-44) along the State Street Warehouse side of the property.

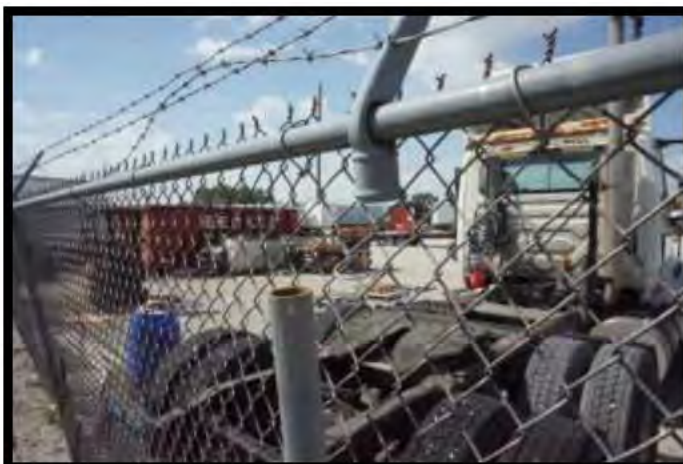
Photograph 41: Broken fence pole (material staging on State Street Warehouse property).

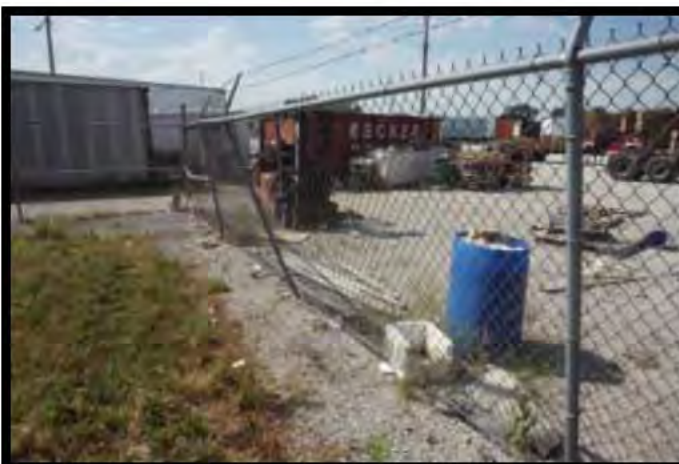
Photograph 42: Bent fence along State Street Warehouse property storage area.

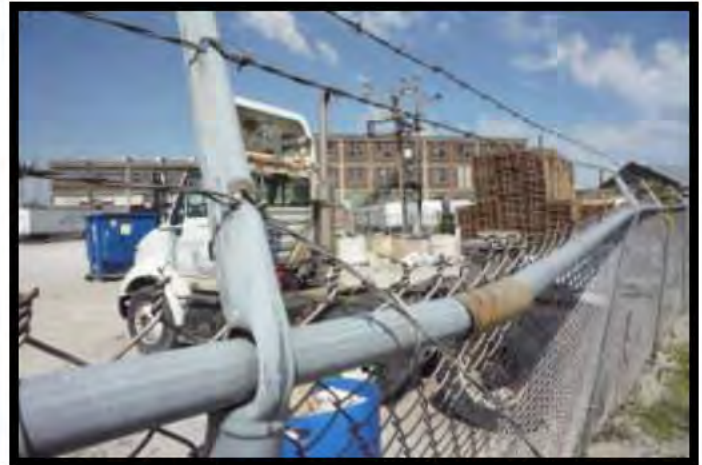
Photograph 44: Bent fence and broken barbed wire (material staging on State Street Warehouse property).

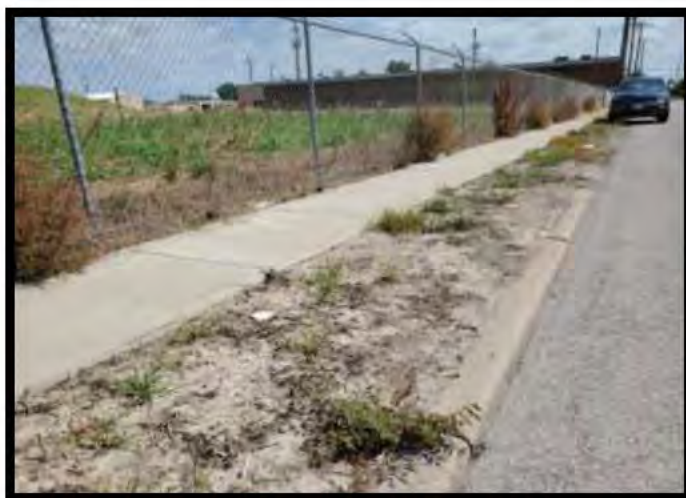
Photograph 69: Vegetation along State Street sidewalk.

- The Group has requested that its lawn maintenance contractor, Munie Greencare Professionals (Munie), check the vegetation more frequently (and cut it when necessary), cut and remove several bushes along the sidewalk, and remove some vegetation from the fence along State Street (Attachment 5, photographs 68, 70, and 71). Munie has also been requested to replant grass in the area between the sidewalk and State Street (Attachment 5, photographs 68-71).

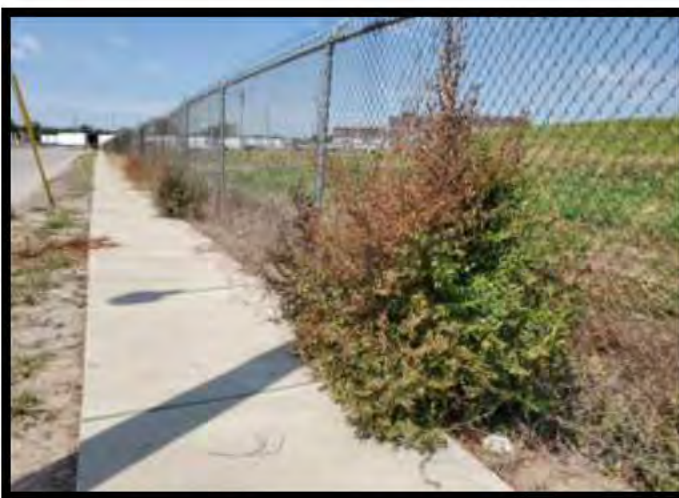
Photograph 70: Vegetation along State Street sidewalk.

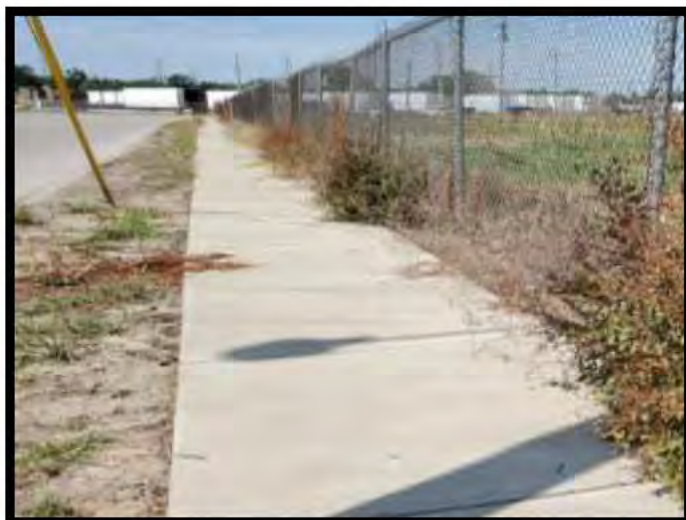
Photograph 71: Vegetation along State Street sidewalk.

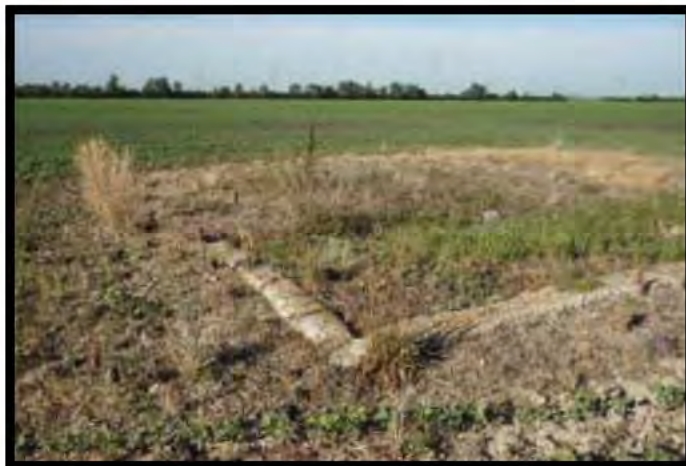
- At Sand Road (also a remote fill property remediated by EPA), some scattered battery case chips were observed on the ground surface within the foundation area of a former building on the property (Attachment 7, photographs 3-10, 13, and 14). The property is currently being farmed; however, no evidence of disturbance of the soil within the foundation area was observed.

Photograph 3: Sand Road property, concrete foundation.

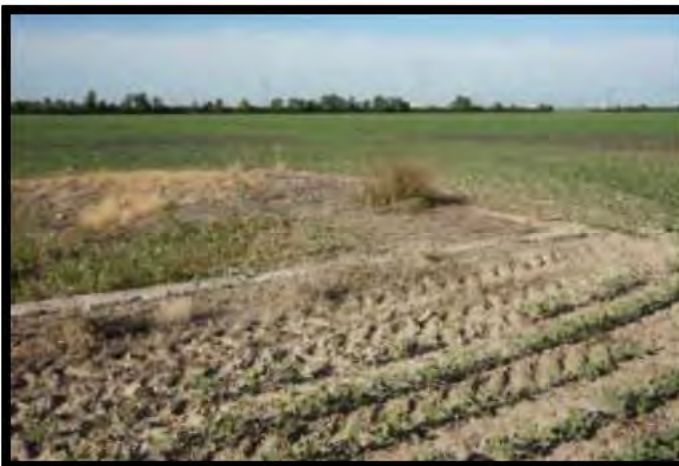
Photograph 4: Sand Road property, concrete foundation.

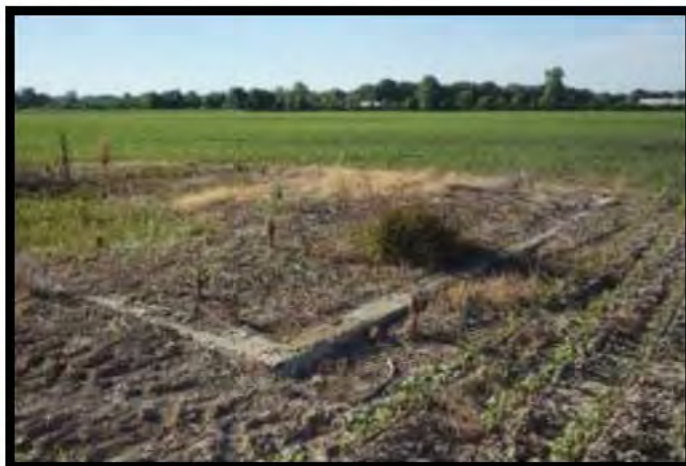
Photograph 5: Sand Road property, concrete foundation.

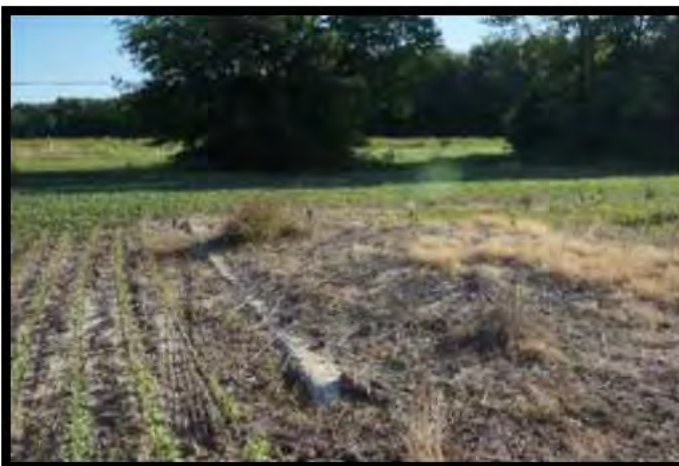
Photograph 6: Sand Road property, concrete foundation.

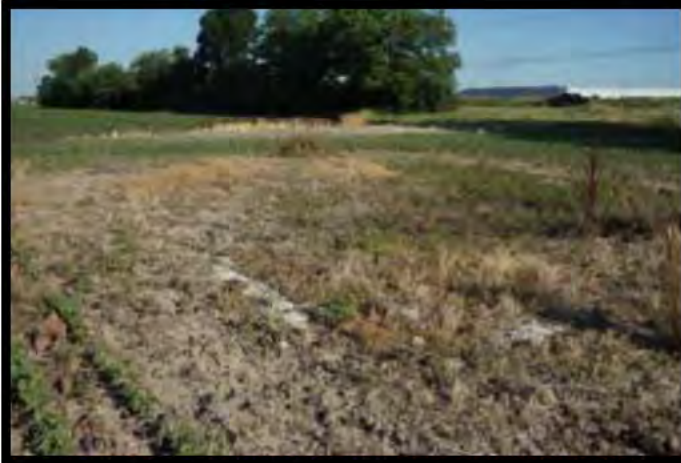
Photograph 7: Sand Road property, concrete foundation..

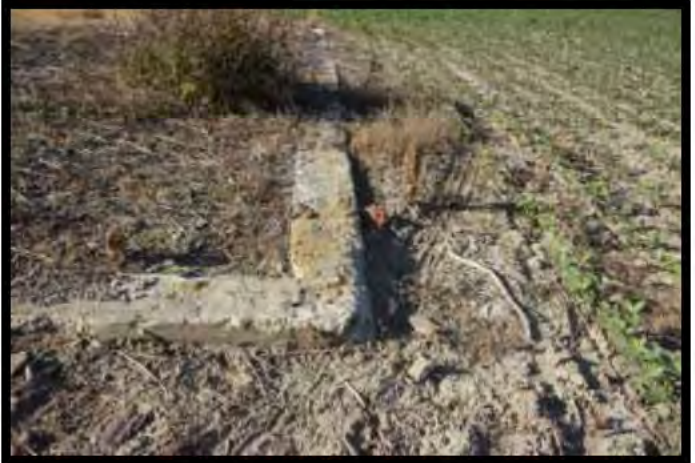
Photograph 8: Sand Road property, concrete foundation.

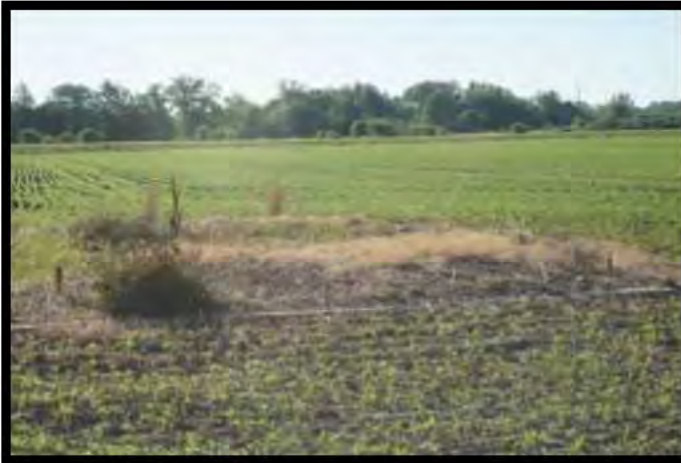
Photograph 9: Sand Road property, concrete foundation.

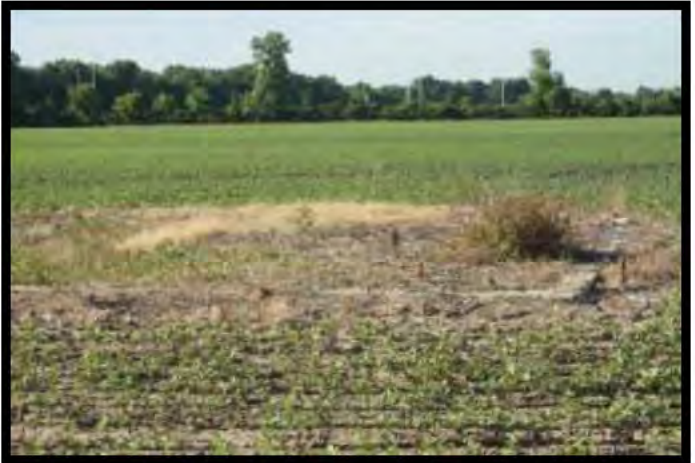
Photograph 10: Sand Road property, concrete foundation.

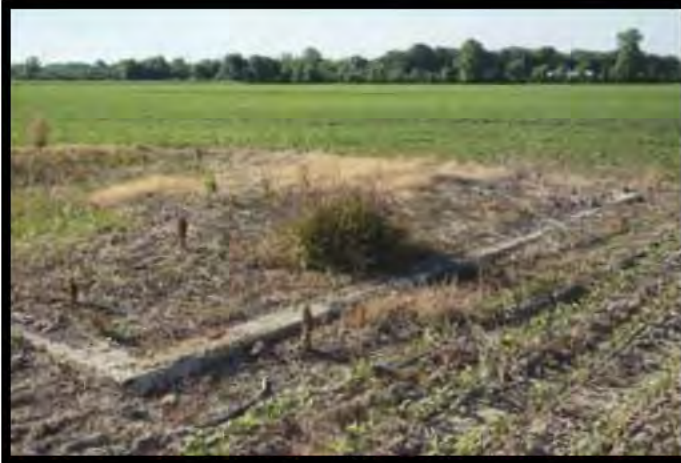
Photograph 13: Sand Road property, concrete foundation.
